# Mitigation of Dirty Electricity from Solar Inverters

## Capacitive Parallel Filters Don't Do the Job

# Mitigation of Dirty Electricity from Solar Inverter with DNA Line Filter

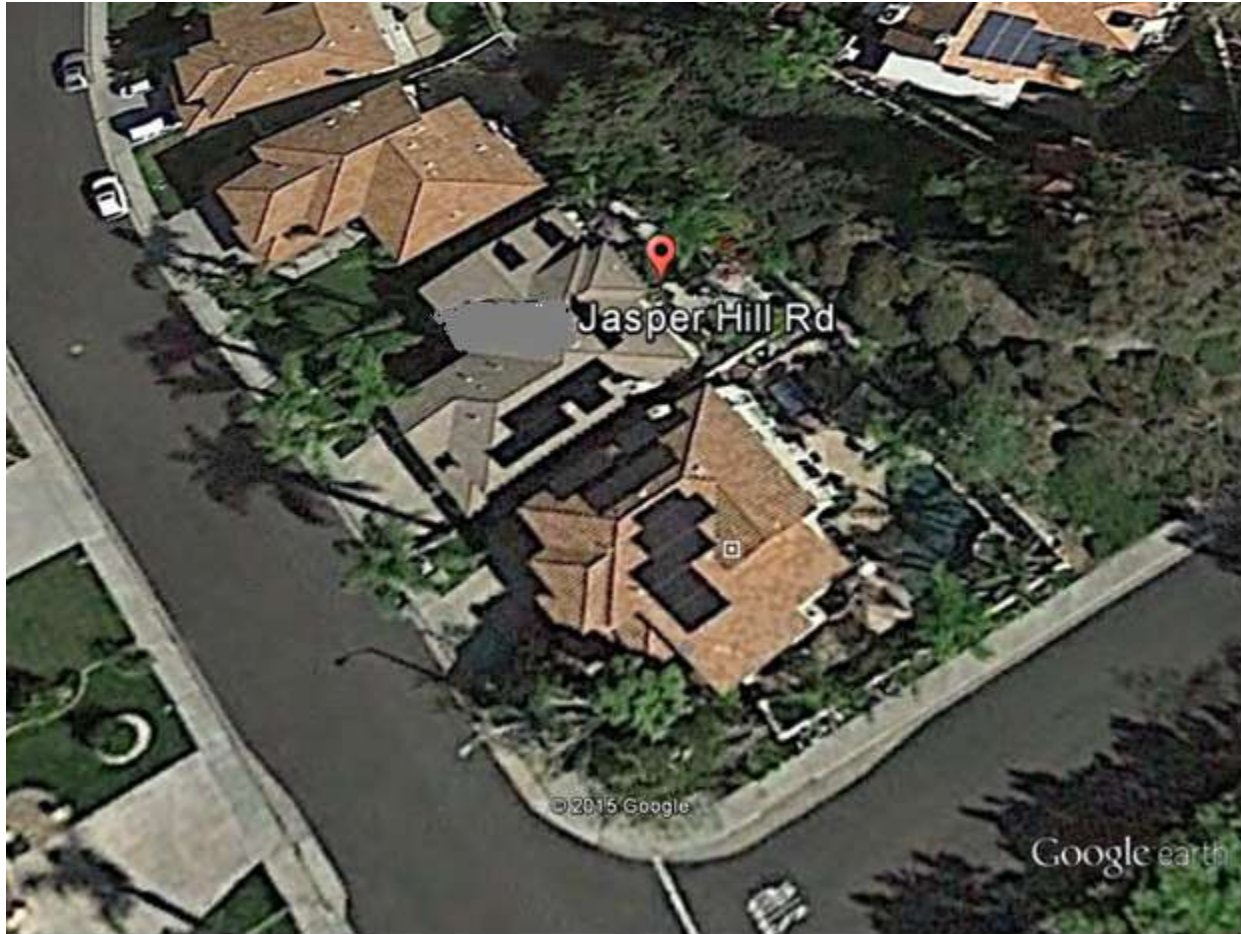
SV roof mounted panels in Trabuco Canyon CA. Main array faces SSW and 3 other arrays WSW.

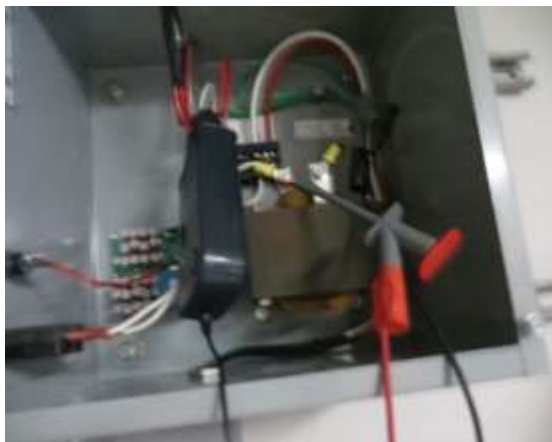
Figure 8 Test Points at DNA Filter.

Oscilloscope voltage and current waveforms were recorded, with one SV inverter operating, before and after the DNA line filter using active differential probe (volts = blue) and clamp-on meter (amps = red) to Pico-scope and laptop. The new subpanel and DNA line filters are shown in figure 7, with the hookup to the DNA line filter in figure 8.
